Navajo Abandoned Uranium Mine Site Screen Report

Ruby No. 1 AUM Site

Navajo AUM Eastern Region

Weston Solutions, Inc.

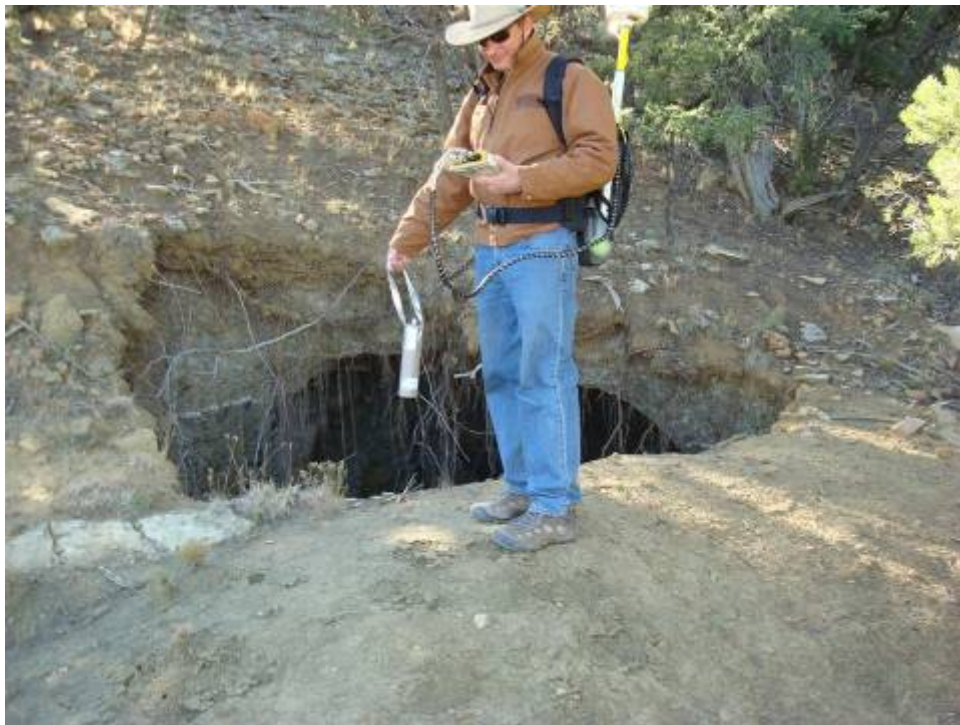
Photo 3. Ruby 1 Mine site, adit located on southern hillside

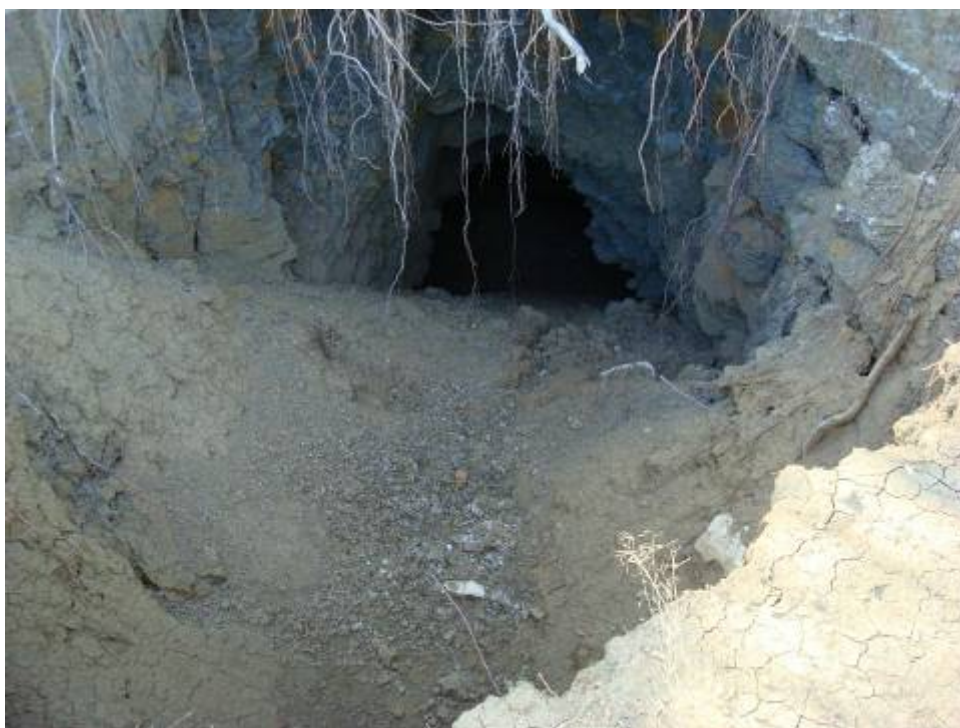
Photo 4. Ruby 1 Mine site, interior view of adit

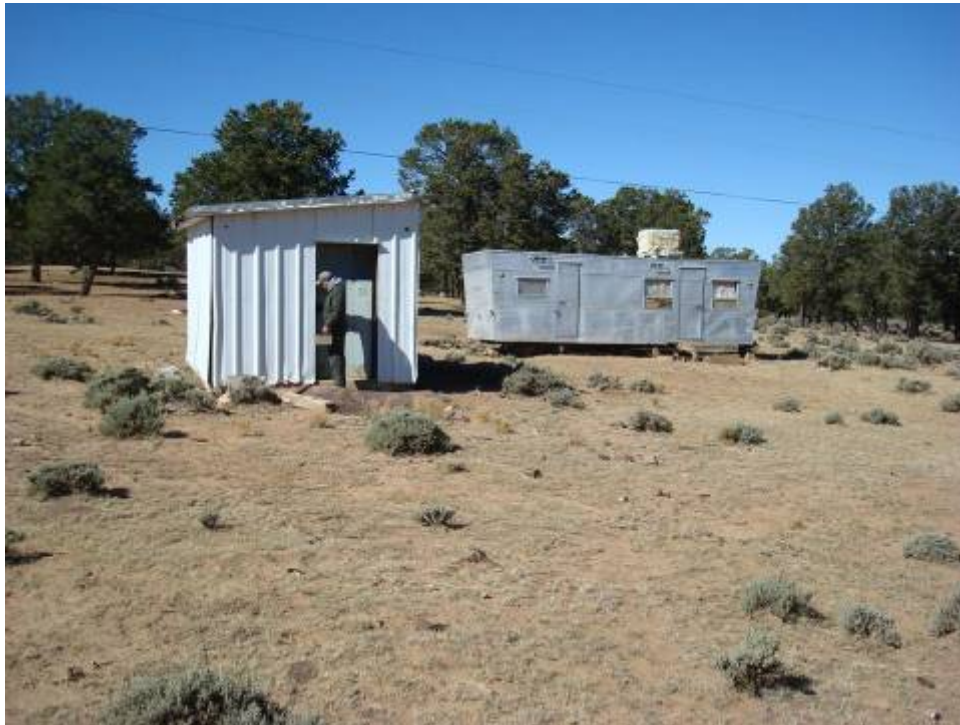
Gamma radiation measurements were collected from materials and buildings acquired from the mine that located at the Yapan property ranged from 11,000 to 14,000 cpm.

Photo 5. Ruby 1 Mine site, former mine buildings at the Yapan residence

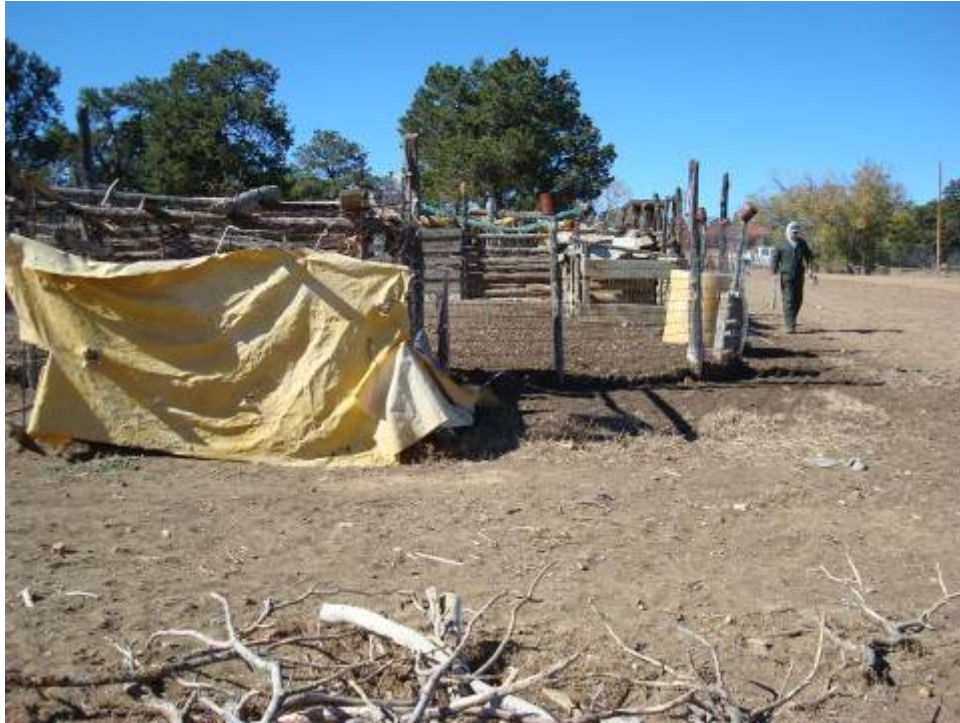
Photo 6. Ruby 1 Mine site, yellow tarps from the mine at the Yapan residence
